INDOOR AIR QUALITY ASSESSMENT

**Medford High School
489 Winthrop Street
Medford, Massachusetts**

Prepared by:
Massachusetts Department of Public Health
Bureau of Environmental Health Assessment
September, 2001

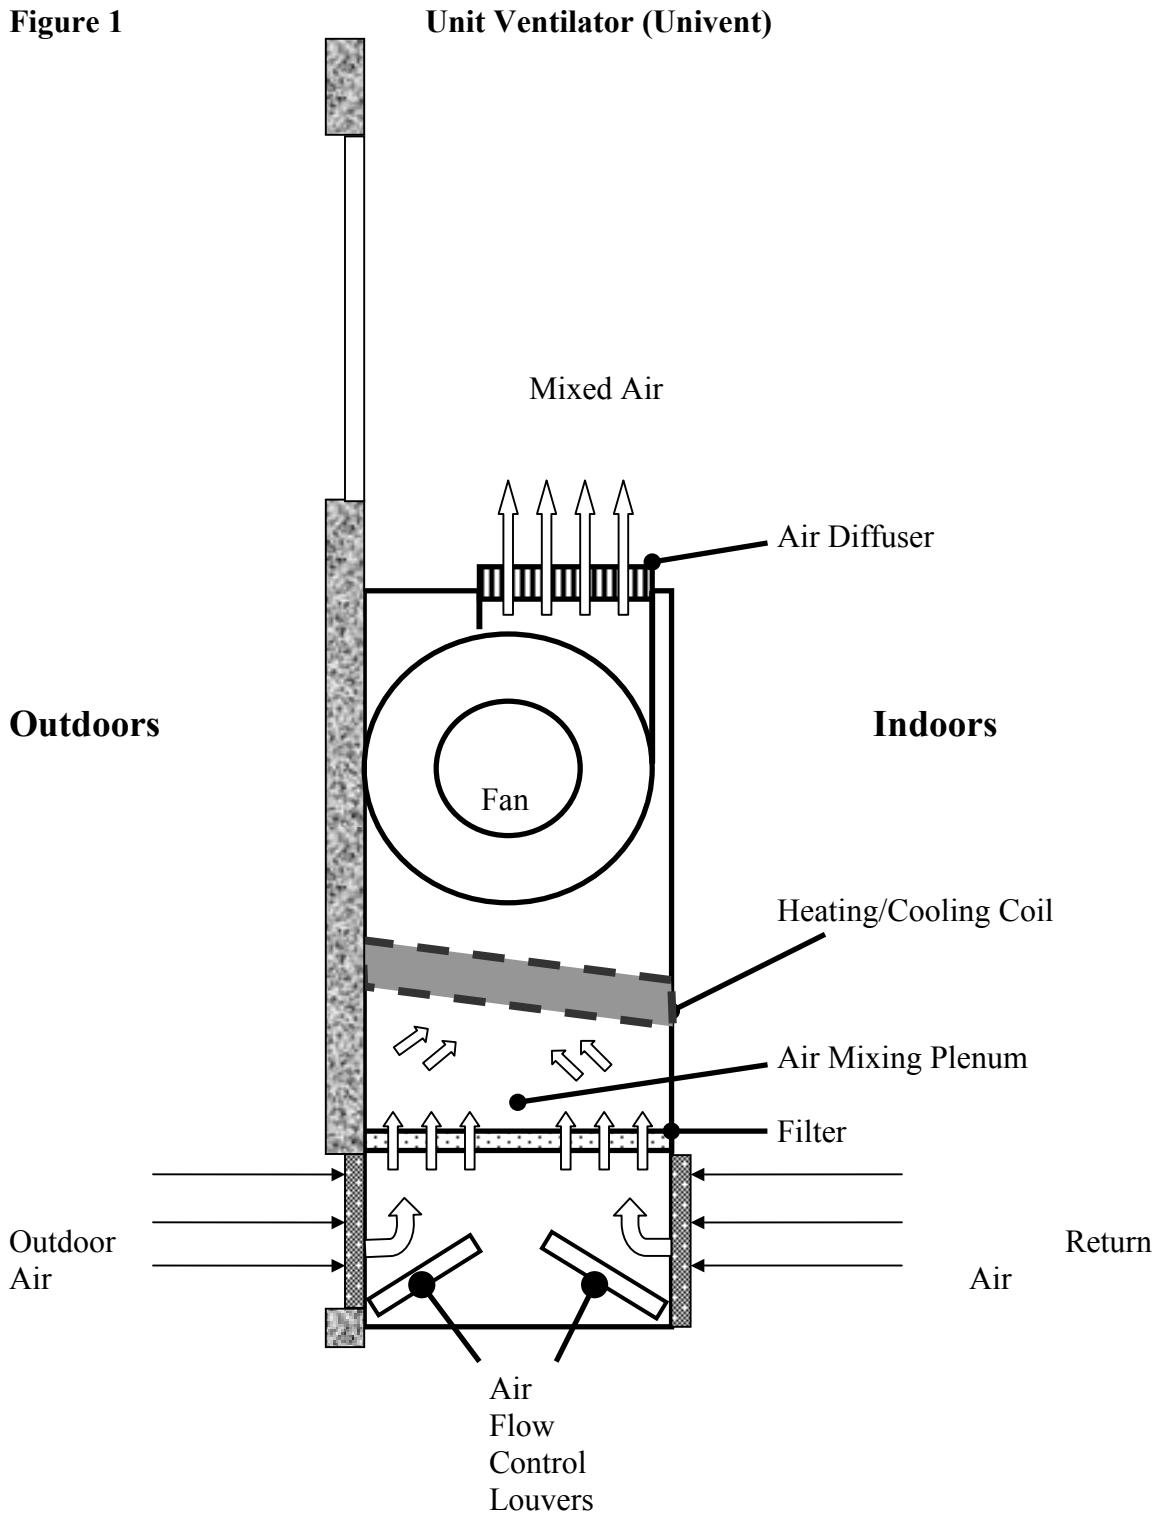
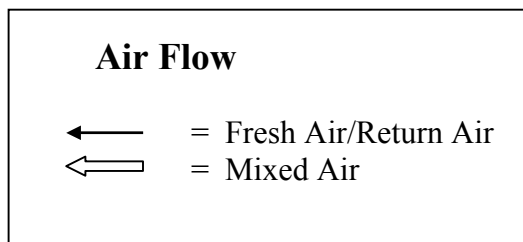
Figure 1

Fresh air in classrooms is supplied by a unit ventilator (univent) system. Univents in exterior classrooms draw air from outdoors through a fresh air intake located on the exterior walls of the building (see Picture 2) and return air through an air intake located at the base of each unit (see Figure 1). Interior rooms contain ceiling-mounted univents that are ducted to fresh air intakes on the roof (see Pictures 3 & 4). Several of these were damaged; the air intake in Picture 4 was being supported by a bucket (see Picture 5). Fresh air and return air are mixed, filtered, heated and provided to classrooms through a fresh air diffuser located in the top of the unit. Obstructions to airflow, such as papers and books stored on univents and bookcases, carts and desks in front of univent returns were seen in a number of classrooms. In order for univents to provide fresh air as designed, intakes must remain free of obstructions. Importantly, these units must remain “on” and allowed to operate while these rooms are occupied.
